EDGERTON CITY HALL RESTORATION PROJECT

Recognized for **Excellence** in the **Repair of Masonry Structures** – December 3, 2009
International Concrete Repair Institute – Great Plains Chapter

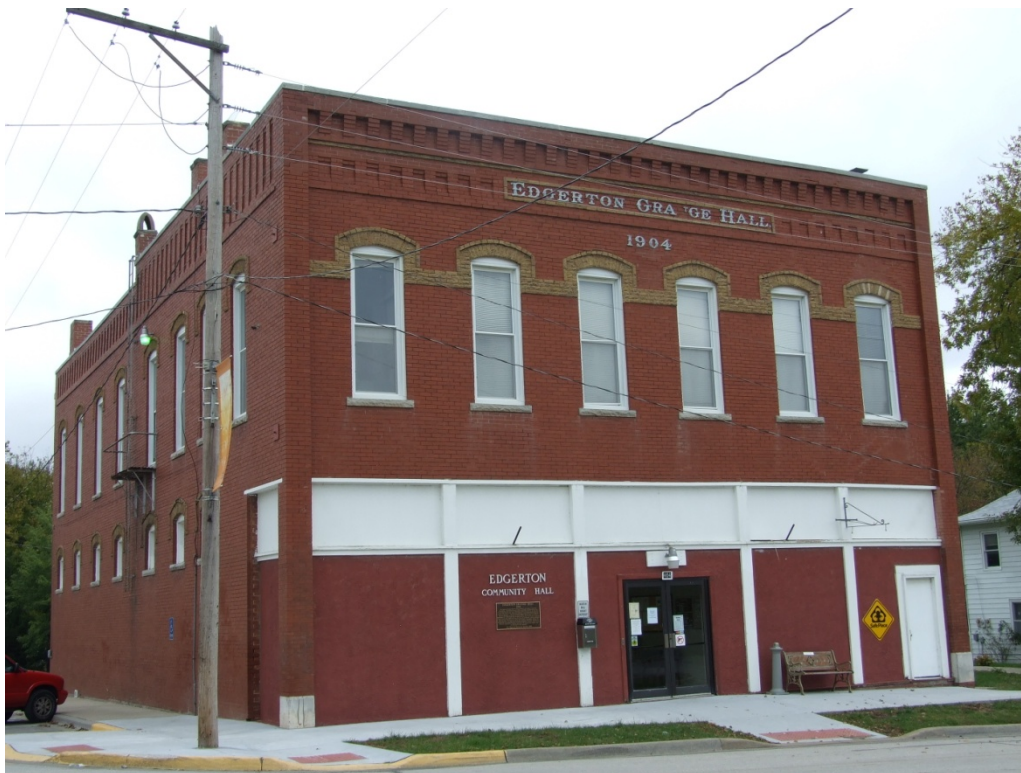
Progressed separation of the exterior brick wall was occurring at the area of concern. This location had a visible crack that went completely thru the load-bearing wall. In addition, the foundation was in need of structural strengthening to prevent further movement of the wall system.

The repair system included removing the exterior sidewalk system to install seven 3 ½” diameter push piers to stabilize the existing concrete foundation system. These piers were installed approximately 7 ft to refusal. No lifting of the existing structure was required, only stabilization.
