COLONIAL FOX THEATRE RESTORATION PROJECT

Recognized for **Excellence** in the **Repair of Special Projects** – December 7, 2012
International Concrete Repair Institute – Great Plains Chapter

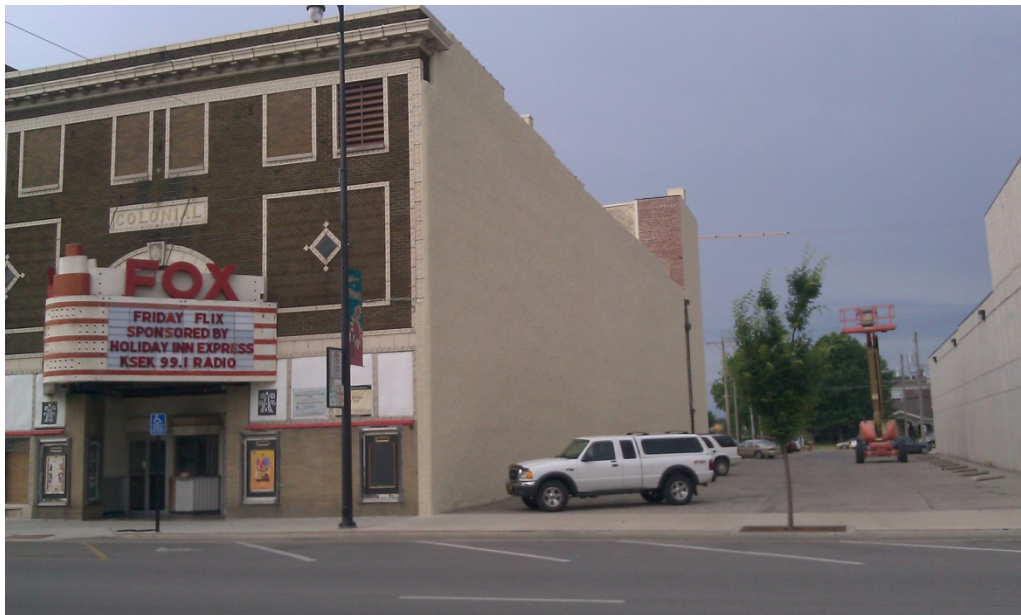
The basement area had become wet and high moisture levels remained over extended periods of time. This prolonged exposure resulted in aggressive corrosion of some of the structure's embedded reinforcing steel, thus resulting in cracking, delaminations and spalling of many of the concrete floor beams.

The deteriorated concrete floor beams were reinforced and strengthened with a carbon fiber reinforced polymer (CFRP) system after the concrete was repaired.
